Service Report

Site Name: Lower Longwood Lake

Date: 8/9/2019

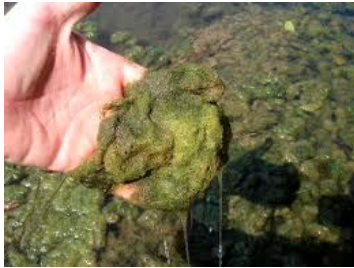
Waterbody	Lower Longwood Lake					
Secchi (feet)	4	Dissolved Oxygen (ppm)	8.6	Posted Water Use Rescriptions		
Temp(F)	78	PH	6.5	Hardness	95	<input checked="" type="checkbox"/> Yes <input type="checkbox"/> No
Type of Service	<input type="checkbox"/> Survey <input checked="" type="checkbox"/> Treatment <input type="checkbox"/> Fountain Service <input type="checkbox"/> WQ Sample Service <input type="checkbox"/> Other Service					
Species Treated	Filamentous					
Comments	<p>Surveyed the waterbody, observed the minor growth of Filamentous Algae in the cove.</p> <p>Treated the targeted nuisance vegetation with an algaecide to help slow and control the growth.</p> <p>Overall condition of the lake is good. Past treatments are working well.</p> <p>Note: Spoke to Jeff regarding surface film on the water. Film was caused by decomposing algae.</p> <p>A.T. will return for further management.</p>					
	Aquatic Algae Present Filamentous

Filamentous
