LMS Service Report

Site Name: Lower Longwood Lake

Date: 5/23/2022

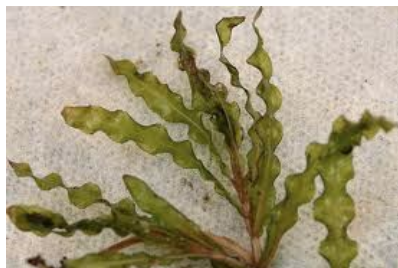
Curly Leaf Pondweed
